UPPER GILA RIVER FLUVIAL GEOMORPHOLOGY STUDY

GEOMORPHIC ANALYSIS ARIZONA

US Department of the Interior
Bureau of Reclamation

DECEMBER 31, 2003

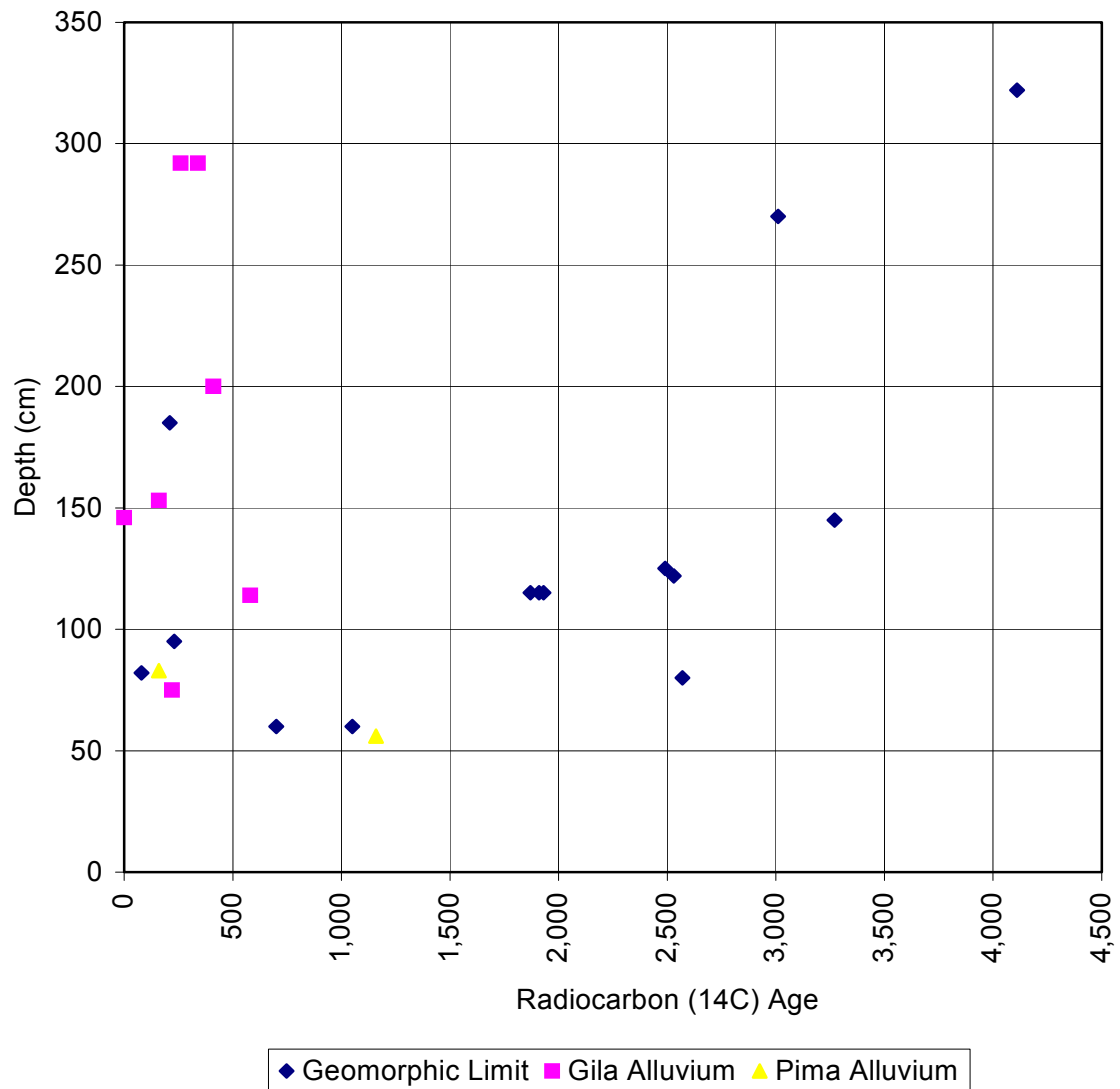
Figure 2. Radiocarbon age versus depth of sample.

Elevation above the modern Gila River and lateral position in the landscape also characterizes the alluvial surfaces, although moderate variability exists in these factors. For instance, the Gila alluvium is generally the lowest in elevation and closest proximity to the Gila River, while alluvium associated with the Geomorphic Limit is generally the highest in elevation and furthest away from the Gila River. The Pima alluvium is an intermediate surface between the Gila alluvium and Geomorphic Limit alluvium.

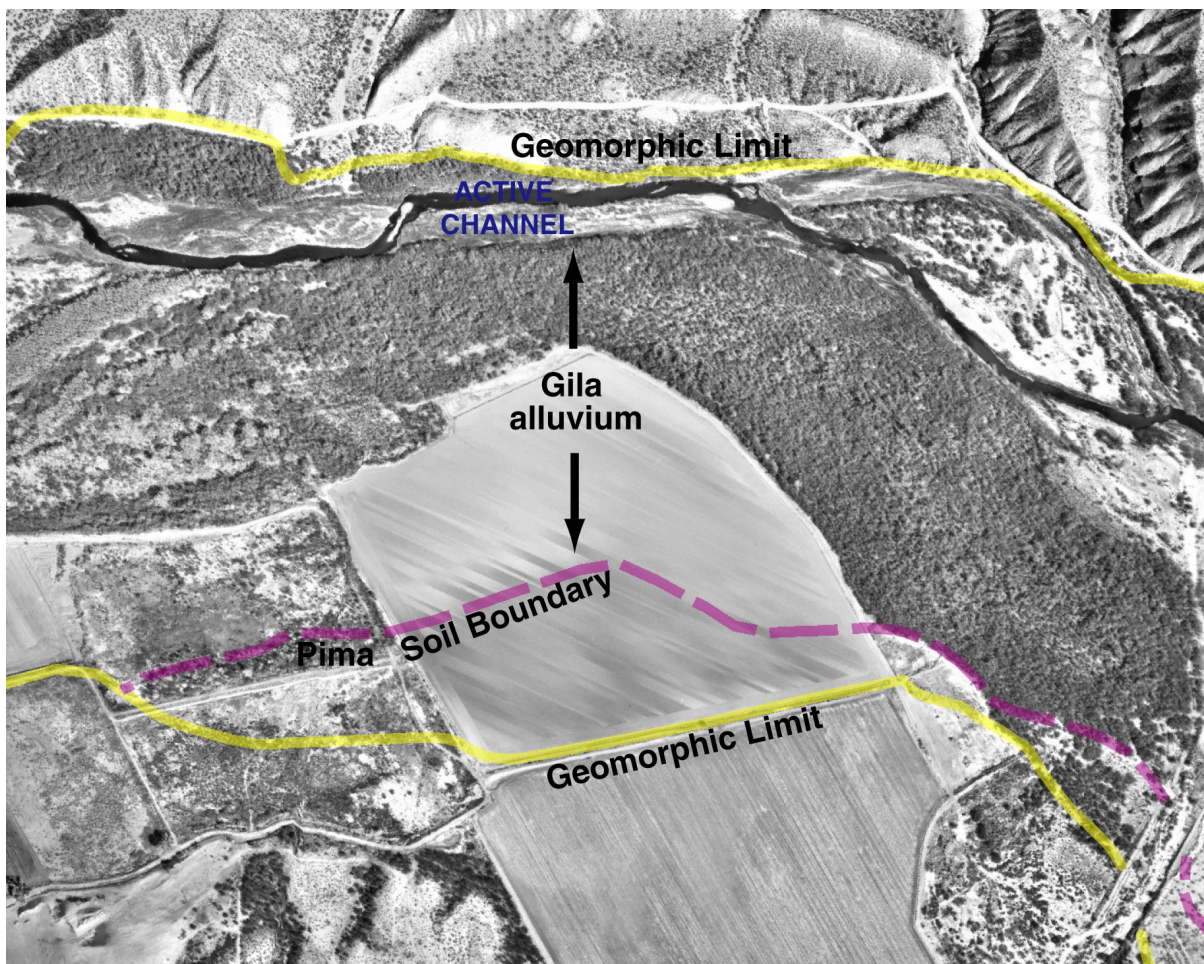
Figure 3. Example showing the lateral extent of the Gila alluvium.

The geomorphic map is a tool for assessing river stability rather than mapping the extent of individual alluvial or bedrock units. The geomorphic map shows two extents of lateral movement for the Gila River. The Pima Soil Boundary is the contact between intermediate alluvium with soils of the Pima Soil Series and young alluvium with soils of the Gila Soil Series. The Geomorphic Limit of flood evidence is the boundary within which the Gila River channel has migrated over at least the past 1,000 years. The Geomorphic Limit is defined by tonal signatures on aerial photography, receding flood waters observed in post-flood aerial photography that show areas of historical flood inundation, and observations of soils that are strongly developed and have not been significantly modified by recent floods. In this way, the Geomorphic limit can be defined both by evidence of floods and well as evidence of stable soils. Although not explicitly mapped on the Geomorphic Map, the Gila alluvium with soils of the Gila Soil Series can be inferred to exist between the modern Gila River and the Pima Soil Boundary. If the Pima Soil Boundary is not present at a given location, then the Gila alluvium extends from the Gila River to the Geomorphic Limit (Figure 3).

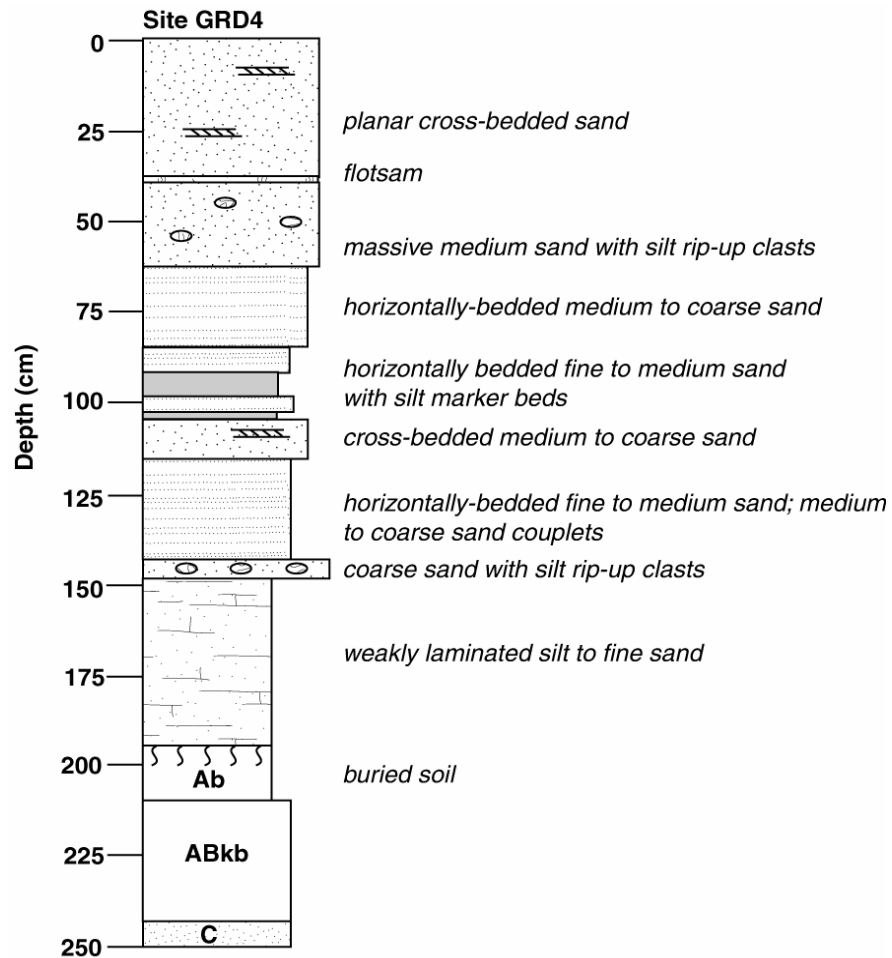
Figure 4. Gila soil profile at site GRD4.

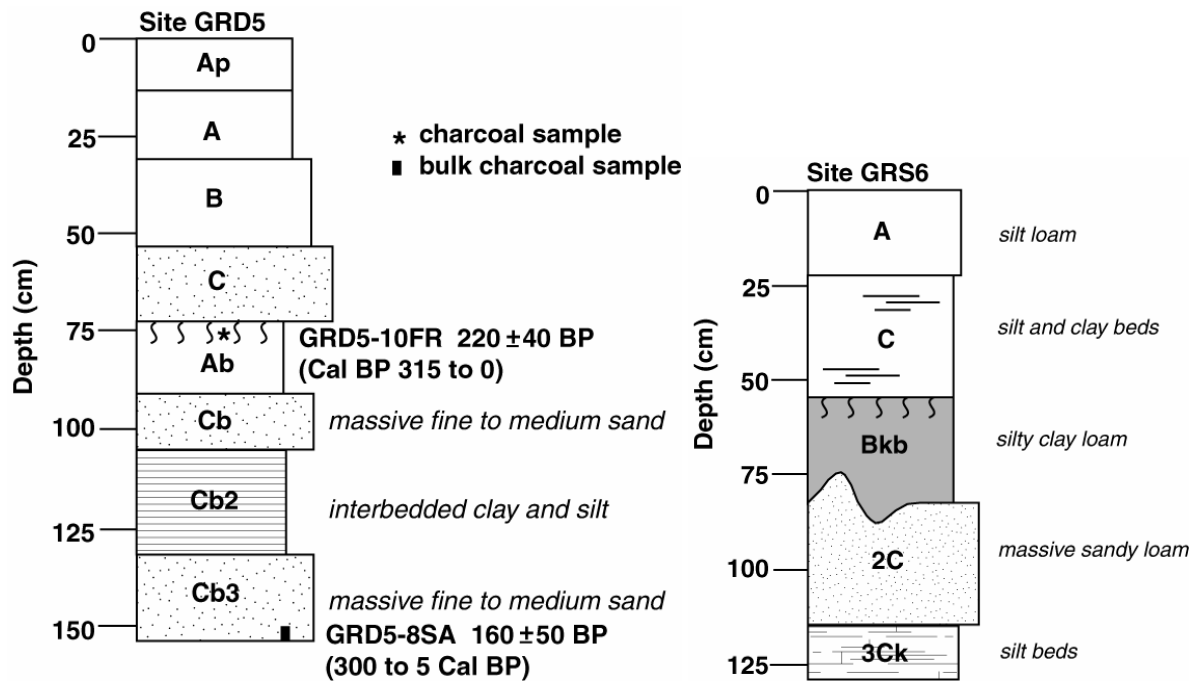
Figure 5. Gila soil profiles at sites GRD5 and GRS6

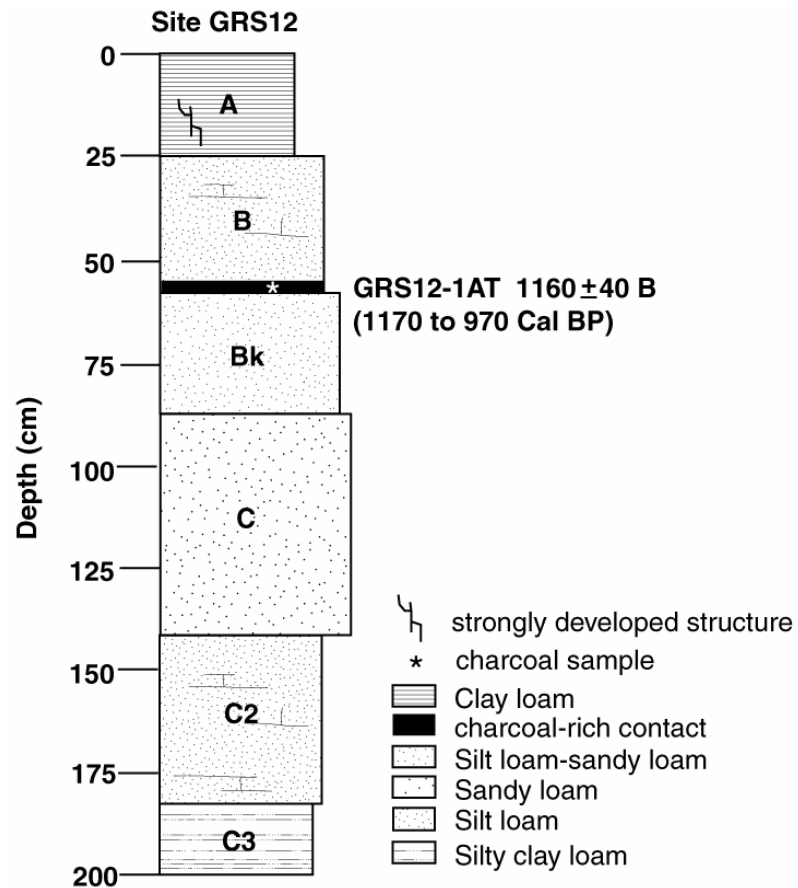
Figure 6. Pima soil profile at site GRS12.

Atriplex (common name saltbush) obtained from a charcoal-rich contact at 56 cm at site GRS12 yielded a date of 1160 ± 40 . Only two dates were obtained for soils in the Pima Soil Series that define the Pima Soil Boundary. The second date yielded an age of 160 ± 30 from a deeper depth at site GRS13 (Figure 7). The lack of other quantitative information from the Pima Soil precludes definitive estimates for the age of this boundary. However, based on bracketing information from younger and older soils, the Pima alluvium is estimated to be several hundred to 1,000 years old.

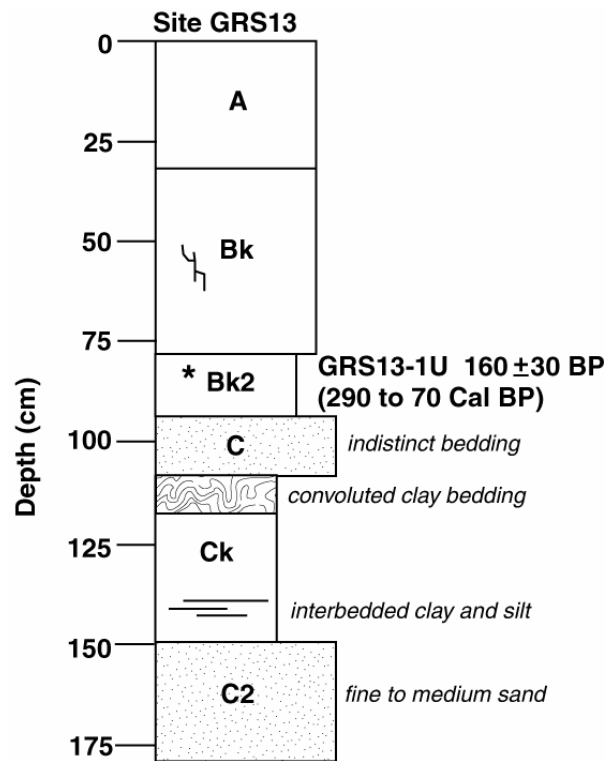
Figure 7. Pima soil profile at site GRS13.

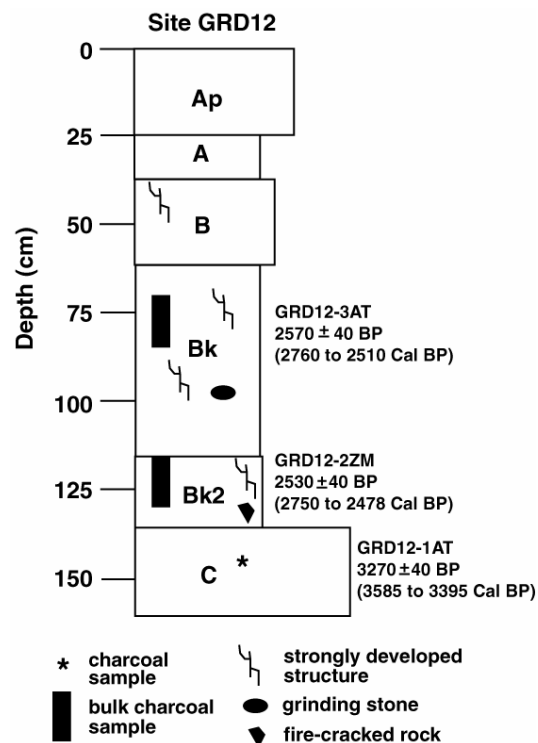
Figure 8. Bank exposure along the Geomorphic Limit, site GRD12.

Several bank exposures and soil pits near the active channel illustrate these characteristics. Site GRD12, located near Railroad Wash in Duncan Valley, exhibits a 25 cm thick plow pan over a 11cm thick A-horizon (Figure 8). Three Bk-horizons are developed to a depth of 135 cm and have silty clay loam to clay textures and strongly developed angular blocky structure. Carbonate development ranges from stage I to stage II- while clay films are prominent to distinct on ped faces. Archaeological features including grinding stones and fire-cracked rock are present in these horizons; no other artifacts were noted. Charcoal collected from these horizons is most likely associated with these artifacts. The charcoal was disseminated throughout the horizons, lacking distinct lenses. Charred *Zea mays* (corn cob) and *Atriplex* (saltbush) charcoal were obtained from the Bk2 and Bk3-horizons and have very similar radiocarbon ages of 2570 ± 40 and 2530 ± 40 . The C-horizon at the base of the profile, described to a depth of 160 cm, has a fine sandy loam texture with coarse sub-angular blocky structure. An additional *Atriplex* charcoal sample collected at a 145 cm depth in the C-horizon has a radiocarbon age of 3270 ± 40 BP.

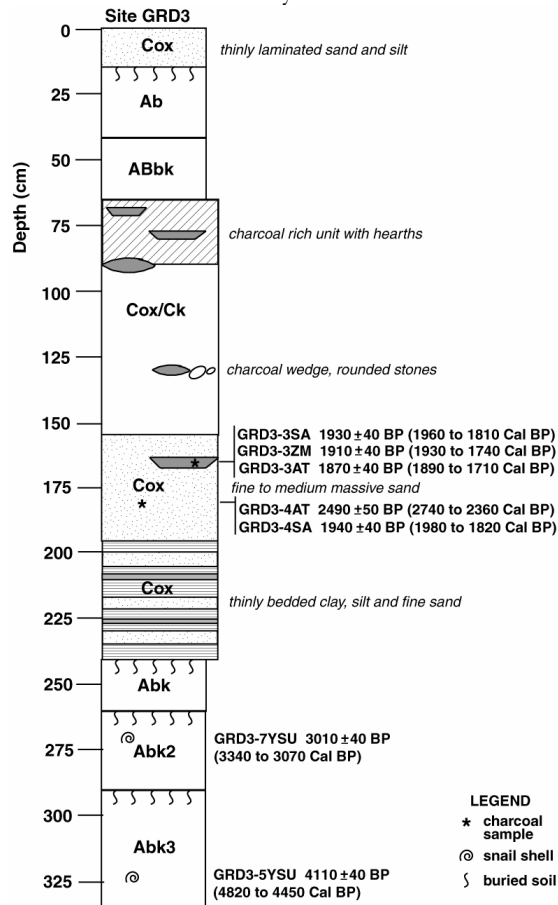
Figure 9. Bank exposure along the Geomorphic Limit, site GRD 3.

Site GRD3 is located approximately $\frac{3}{4}$ mile west of the Greenlee County Fairgrounds along the Gila River. The surface soil is buried by approximately 15 cm of laminated fine sand and silt, which are interpreted to be derived from a nearby tributary. These sediments thin downstream with distance from the tributary mouth (Figure 9). Within the C-horizon of this buried soil are several hearths at various depths and charcoal-rich sand. Rounded stones are also observed within this horizon and appear to be grinding stones. Radiocarbon ages obtained from this horizon average 2028 ± 40 BP from three samples identified from a bulk sample at a depth of 115 cm and 2 samples identified from a bulk sample at a depth of 125 cm. Below a depth of 195 cm, 5-10 cm thick beds of silt, clay and fine sand overlie two buried soils with moderate to strongly developed sub-angular blocky structure, silt loam texture and stage I carbonate. Charcoal samples from the two buried soils have radiocarbon ages of 3010 ± 40 BP and 4110 ± 40 BP, respectively.

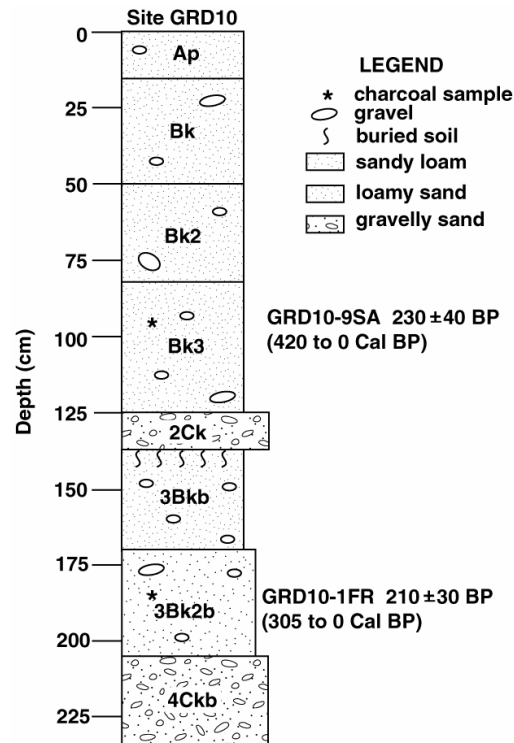
Figure 10. Bank exposure along the Geomorphic Limit, site GRD 10.

Site GRD10 is located upstream of Apache Creek and is composed of fine grained and gravelly alluvium that may be associated with Apache Creek or Kaywood Wash. The surface soil extends to a depth of 137 cm and consists of moderately to strongly developed structure with sandy loam texture and approximately 10% gravel in the B-horizons (Figure 10). The C-horizon consists of loosely consolidated rounded gravels with stage I carbonate. An additional soil is buried below the surface soil. No A-horizon is preserved. This soil is moderately developed with sub-angular blocky structure, sandy loam to loamy sand texture and stage I carbonate (Gile et al., 1981). Charcoal material sampled at depths of 95 and 185 cm and have radiocarbon ages of 230 ± 40 BP (420 to 0 Cal BP) and 210 ± 30 BP (305 to 0 Cal BP), which are almost certainly younger than the alluvium. These dates point out one of the problems encountered in radiocarbon dating, where the introduction and contamination of young material into an older profile can be a significant source of uncertainty and consternation in estimating its age.

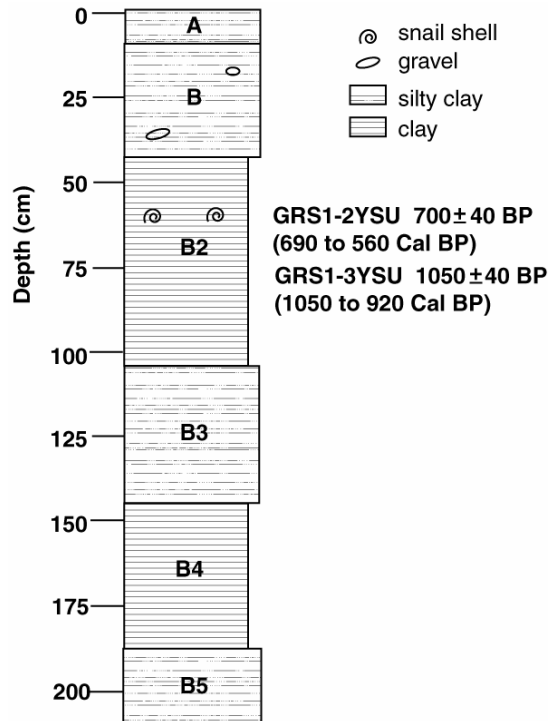
Figure 11. Bank exposure along the Geomorphic Limit, site GRS 1.

Site GRS1 is located near the downstream end of the study area on Doug Hinton's property west of Geronimo. The soil profile has a 10 cm A-horizon, and 5 B-horizons to a depth of 210 cm (Figure 11). The soil is rich in clay, ranging from silty clay to clay texture, with a weak to moderate sub-angular blocky structure. Carbonate accumulations are visible in the lowermost B-horizon with stage I morphology. Snail shell samples have radiocarbon ages of 700 ± 40 and 1050 ± 40 at 60 cm within the B2-horizon.

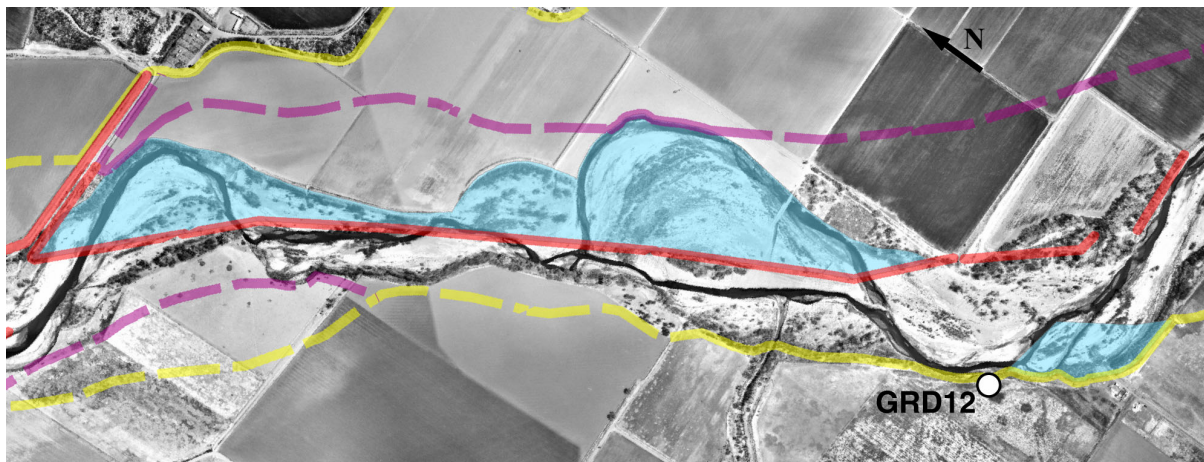
Figure 12. Railroad Wash geomorphic map.

The Railroad Wash reach extends from the left bank near Railroad Wash to the end of the property loss parallel to Lunt Road (Geomorphic Map 30; Figure 12). This reach has experienced erosion of older alluvium along the left bank and young alluvium along the right bank in an area that had been floodplain historically. Levees constructed along the right bank prevented flow from accessing part of the right bank that had been historically flooded during large discharges. Instead, flow was directed at the left bank, eroding the consolidated left bank at site GRD12. The river bend as well as the Railroad Wash alluvial fan appear to have directed floodwaters toward the right bank levee. The breach of the right bank levee accentuated the erosion along this bank, creating asymmetrical meanders related to the levee breach and reentrant flow downstream.

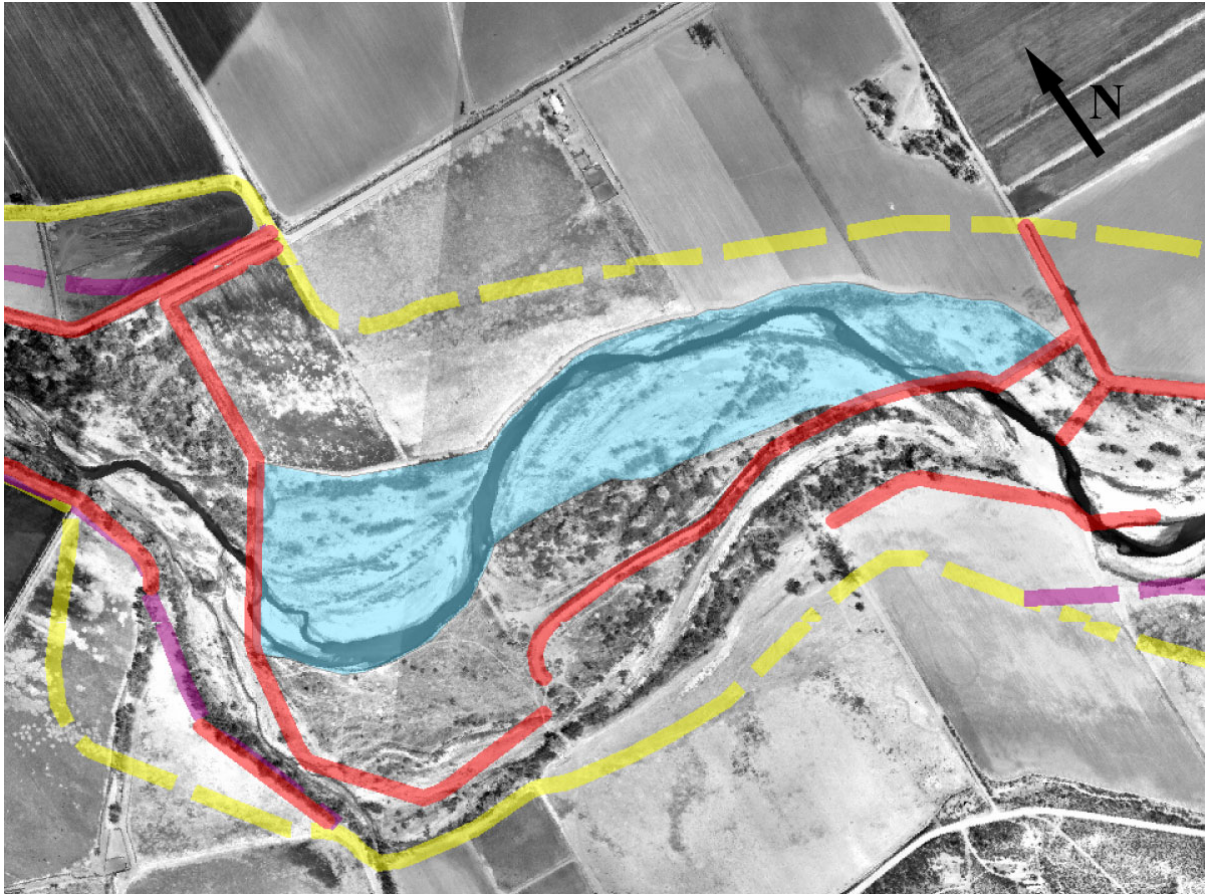
Figure 13. Cutoff meander geomorphic map.

The cutoff meander reach is downstream from the Railroad Wash, and consists of a new channel that was formed during the 1993 and 1995 floods, cutting off a previous meander of the Gila River and effectively reducing the sinuosity of this reach (Geomorphic Map 29; Figure 13). Although it was common for large floods such as the 1978 flood to inundate this part of the floodplain, the main channel had remained in a very similar position throughout the historical period. Following the 1978 flood, extensive levees were constructed in this reach. The inability of the river to access its floodplain along this reach forced the breach of the levee constructed along the right bank and the development of the new channel. Remnants of the 1981 levee can be observed in the 2000 aerial photography. Although the levee appears to have played an important role in this channel avulsion, the erosion occurred within the flood channel and could have been formed naturally as well had the levees not been present.

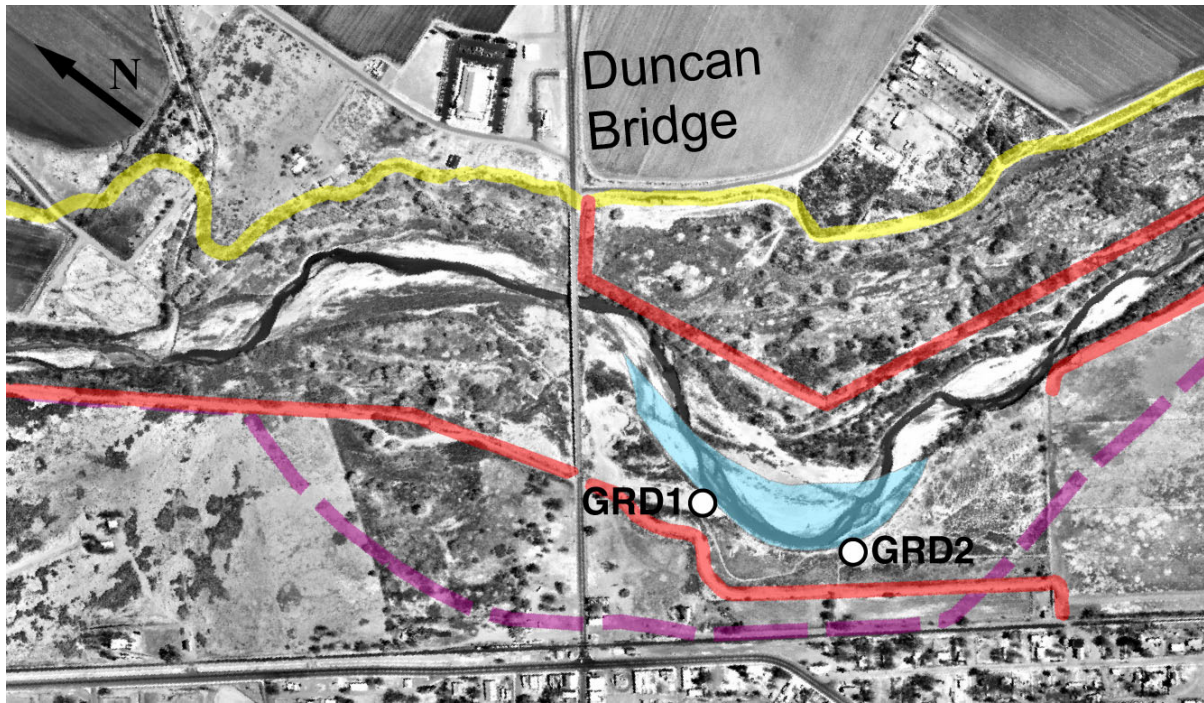
Figure 14. Duncan Bridge geomorphic map.

The Duncan Bridge reach is a short reach located upstream of Duncan Bridge (Map 28 Geomorphic Map; Figure 14). The erosion along the left bank is a result of the propensity of rivers to erode outside bends and exacerbated by extensive levees constructed along the right bank, isolating low channelized surfaces from the main channel. In addition, aggradation in the levied reach has caused repeated breaching of the left bank levee downstream of Duncan Bridge and significant sedimentation over Pima alluvium on the west side of the river.

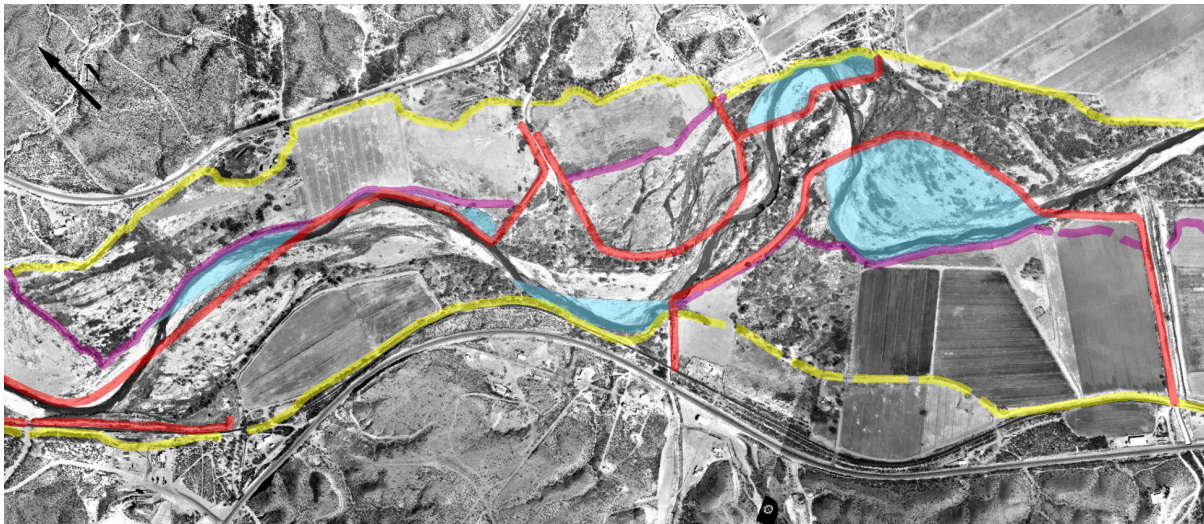
Figure 15. Whitefield Wash geomorphic map.

The Whitefield Wash reach, located just downstream of Duncan Bridge, experienced dramatic channel change between 1992 and 2000 (Geomorphic Map 27; Figure 15). Levees with greater extent following the 1978 flood were constructed presumably in response to inundation of agricultural land. The 1993 and possibly 1994 floods caused erosion of left bank and right bank property as flood flows breached the upstream levee, concentrating flow behind the levee and eroding Gila and Pima alluvium. This erosion created an unusual channel pattern and increased sinuosity. Erosion of levees and minor erosion of land also occurred downstream of this disturbance.

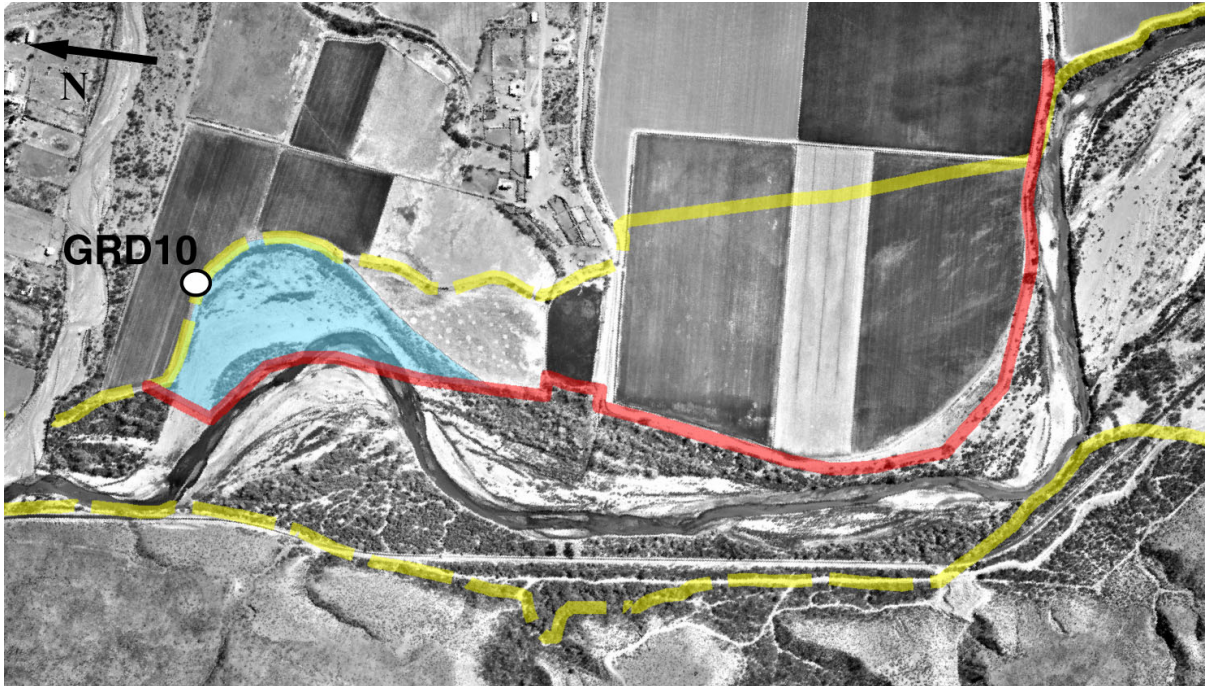
Figure 16. Kaywood Wash geomorphic map.

The Kaywood Wash reach extends from Kaywood Wash to Apache Creek. Property loss occurred on the right bank, where tributary alluvial fan materials are exposed in vertical banks (Geomorphic Map 23; Figure 16). Before levee construction on the right bank, floods inundated the right overbank of Gila alluvium. The levees directed the river toward the left bank and into the right bank levee downstream.

The natural constriction created by the Apache Creek alluvial fan (far left in Figure 16) may have also played a role in creating a backwater zone and increased water surface elevation sufficient to overtop and breach the right bank levee in this location. While portions of this levee were eroded during the flood, the majority of the levee remained intact. Vegetation on the left bank appears to be important in the active channel position in 2000 and may have also played a minor role in property loss from 1992-2000.

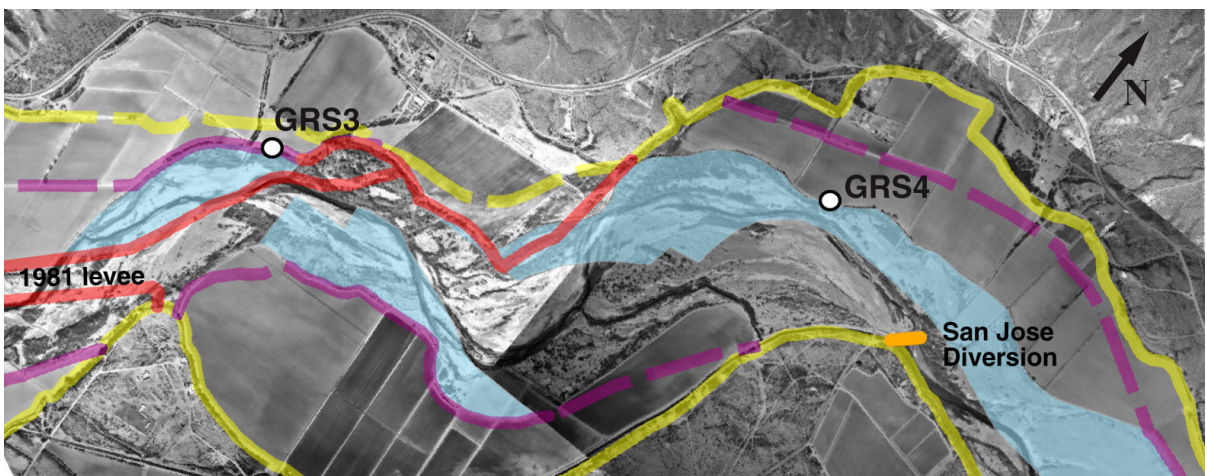
Figure 17. San Jose Diversion geomorphic map.

Property loss associated with San Jose Diversion extends for two miles downstream of the structure. Considerable erosion of Gila alluvium occurs both upstream and downstream of the diversion (Geomorphic Map 17-18; Figure 17). Erosion of Pima alluvium is restricted to downstream of San Jose Diversion. Although some of the erosion, especially upstream of San Jose diversion, can be attributed to natural channel widening from floods, San Jose Diversion also acts as a catalyst to property loss by

directing flood flows into the right bank directly downstream of the structure. This bend sets up the erosion of meanders downstream. During floods in recent decades the river has increased in sinuosity, eroding both right and left banks as the meander propagated downstream.

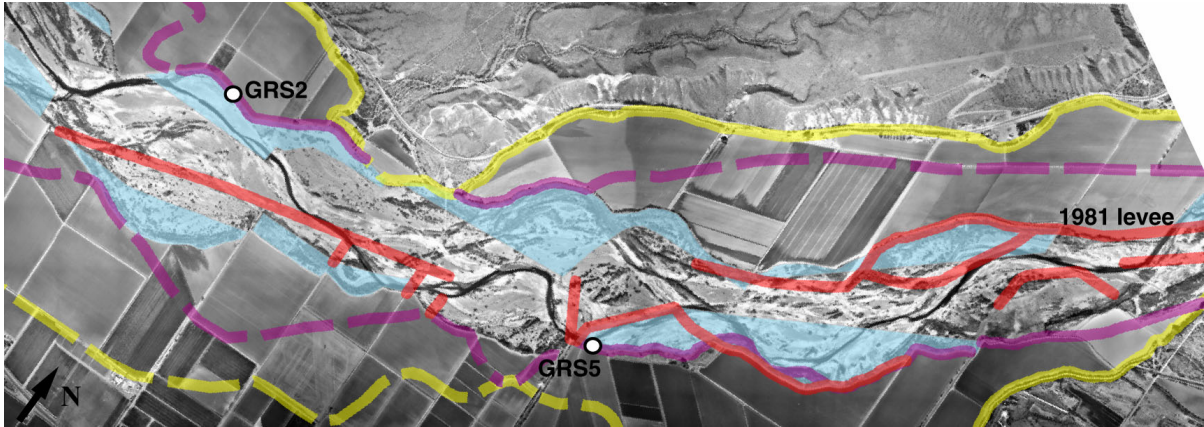
Figure 18. San Jose Wash geomorphic map.

This reach is located near San Jose Wash, where numerous levees were constructed following the 1978 flood (Geomorphic Map 15-16; Figure 18). Some of these levees were constructed along farmland while others were constructed in the channel. The majority of property loss occurred before the construction of these levees and was presumably caused by the flood of 1978. 1981 levees were eroded in the following decades during large floods. It thus appears that in this reach, property loss is mostly related to natural processes of channel widening.

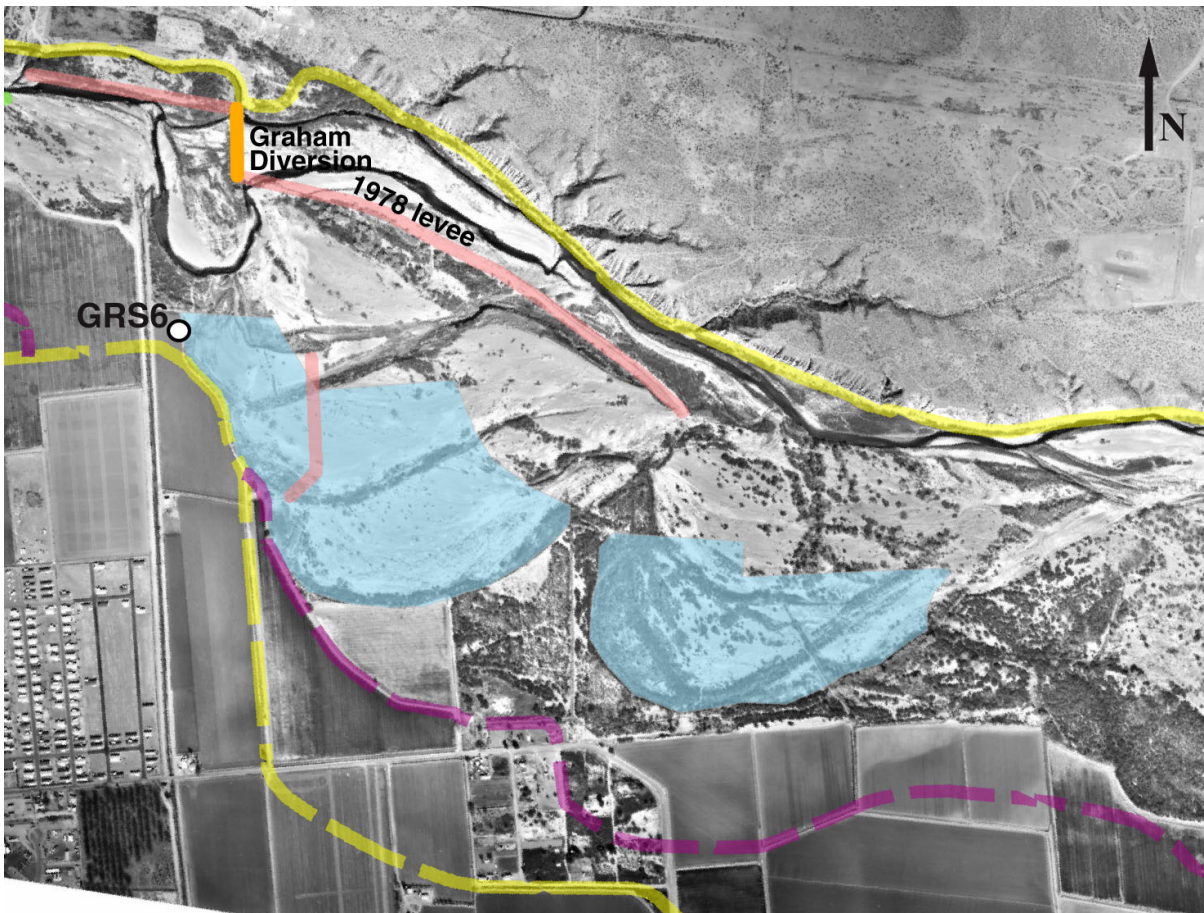
Figure 19. Graham Diversion geomorphic map.

Levees were constructed upstream of Graham Diversion to direct flow over the diversion dam. During large floods, water overtopped this levee, which directed it toward the left bank, causing the erosion of farmland near the ditch between Safford and Hollywood (Geomorphic Map 14; Figure 19). A levee constructed along this property was not successful in preventing the erosion. Further upstream, channel morphology has the appearance of many generations of similar failure due to aggradation behind the diversion and lateral migration. This area has experienced repeated erosion, as much of the mapped property loss was part of the channel in 1935 (Figure 20).

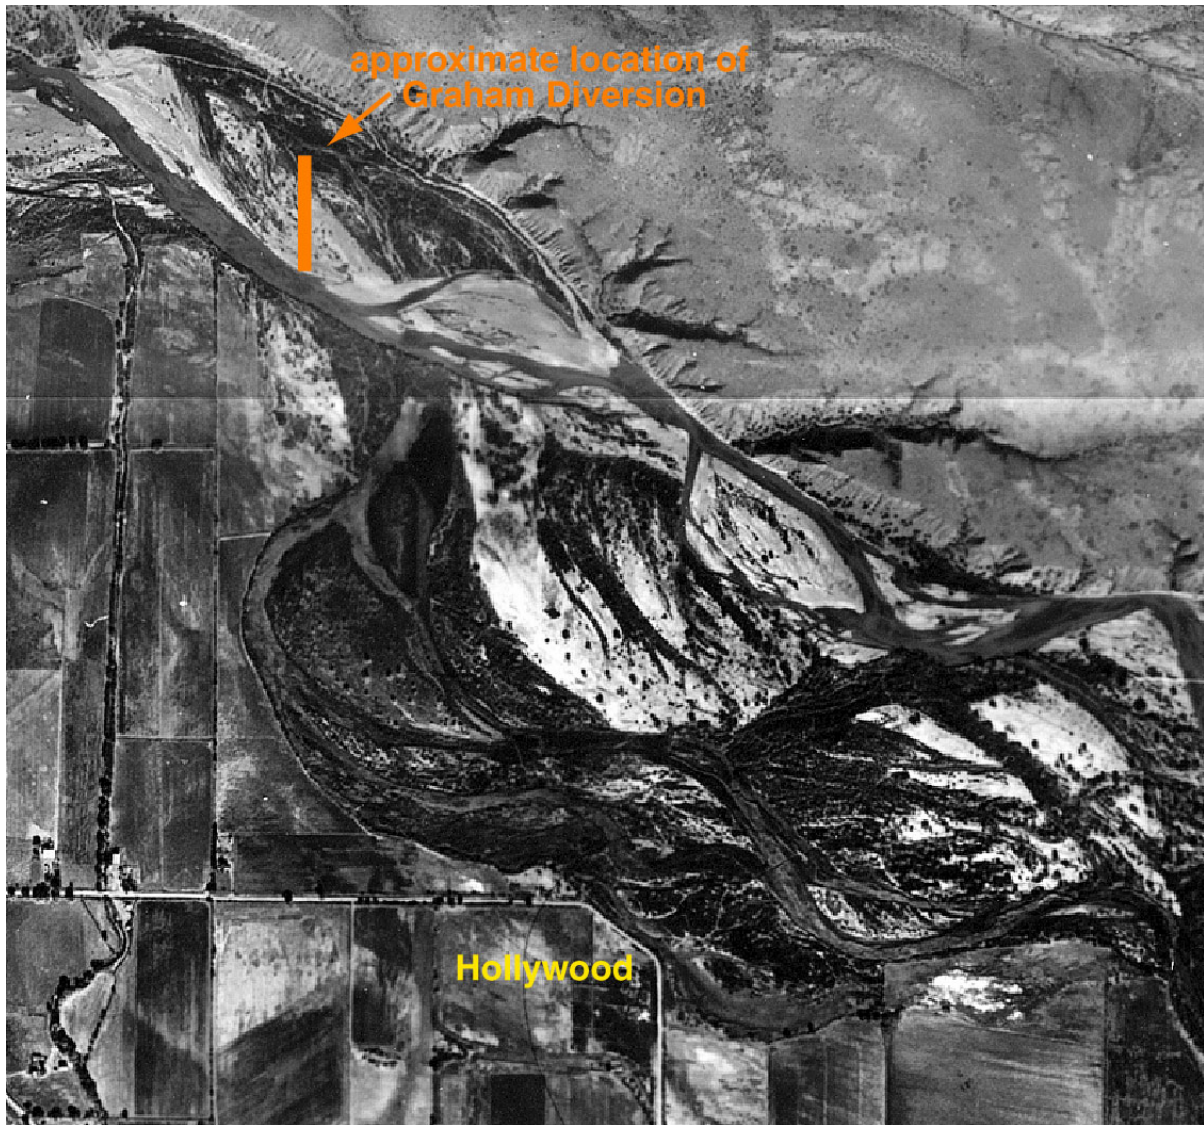
Figure 20. 1935 aerial photograph of Graham Diversion.

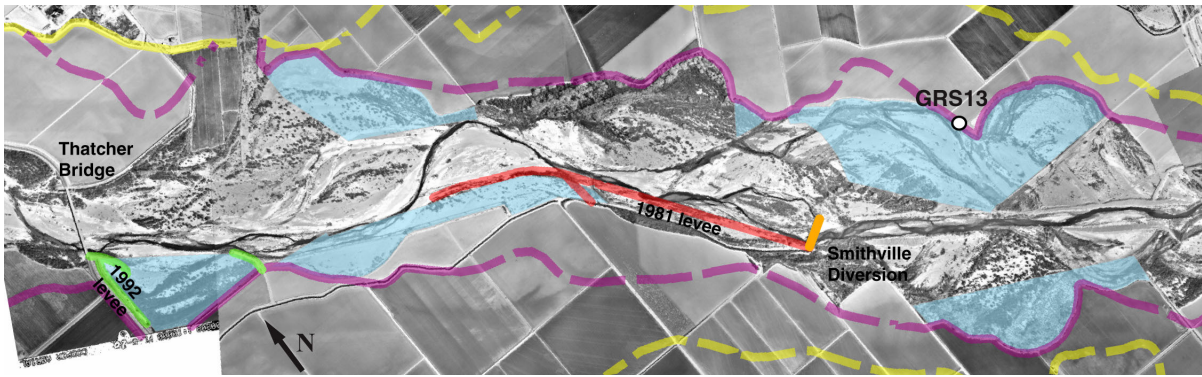
Figure 21. Smithville Diversion-Talley Wash geomorphic map.

The Smithville Diversion reach is located between Safford and Thatcher (Geomorphic Map 12; Figure 21). The river is dredged and lined with unconsolidated levees upstream of the Smithville diversion. The apparent intention of the levees is to direct flow over the diversion. Flood flow during the 1980's and 1990's was redirected toward the banks, eroding Gila alluvium and the margins of Pima Soil on both sides of the river. Flow over Smithville Diversion directed floods toward the right bank downstream due to the orientation of the diversion and levee on the left bank, which eroded Pima Soil near Talley Wash. Alluvium at the downstream end of the left bank levee to Thatcher Bridge was also eroded during floods along with part of the levee. The area near the 1992 levees is one of repeated erosion and land leveling during the historical period (1935-2000).

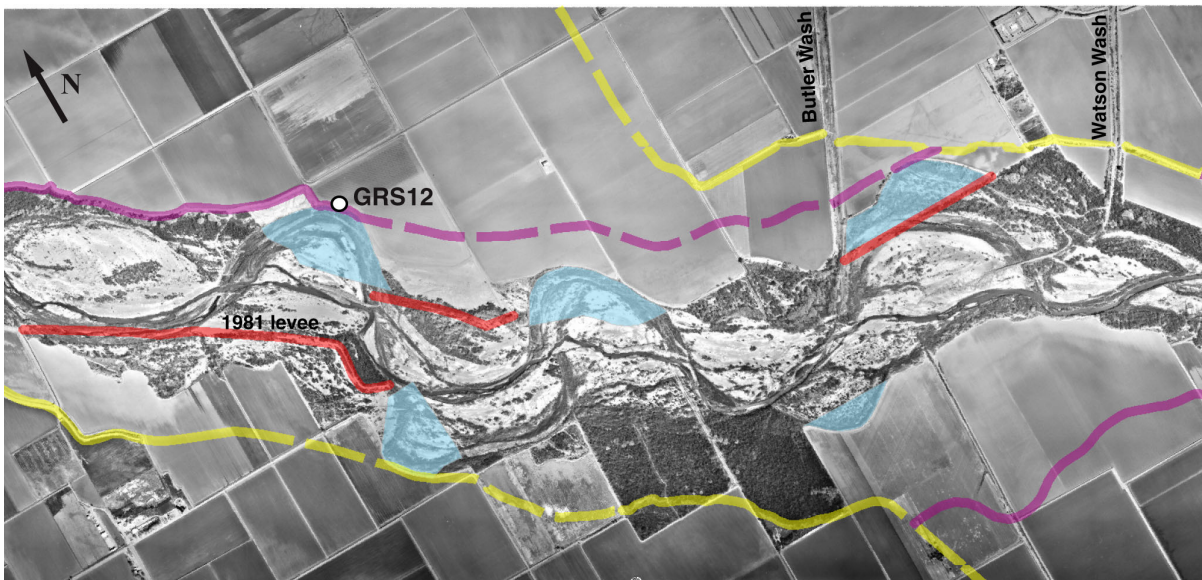
Figure 22. Watson and Butler Wash geomorphic map.

The Watson and Butler reach extends from Watson and Butler washes to the first southwest corner of Safford-Bryce Road near the Gila River (Geomorphic Map 10-11; Figure 22). A levee constructed following the 1978 flood between Watson and Butler washes on the right bank, caused erosion of the left bank immediately downstream and propagation of a new meander train. The exaggerated meanders continued downstream for approximately two miles, eroding some banks that are several hundred to thousands of years old.

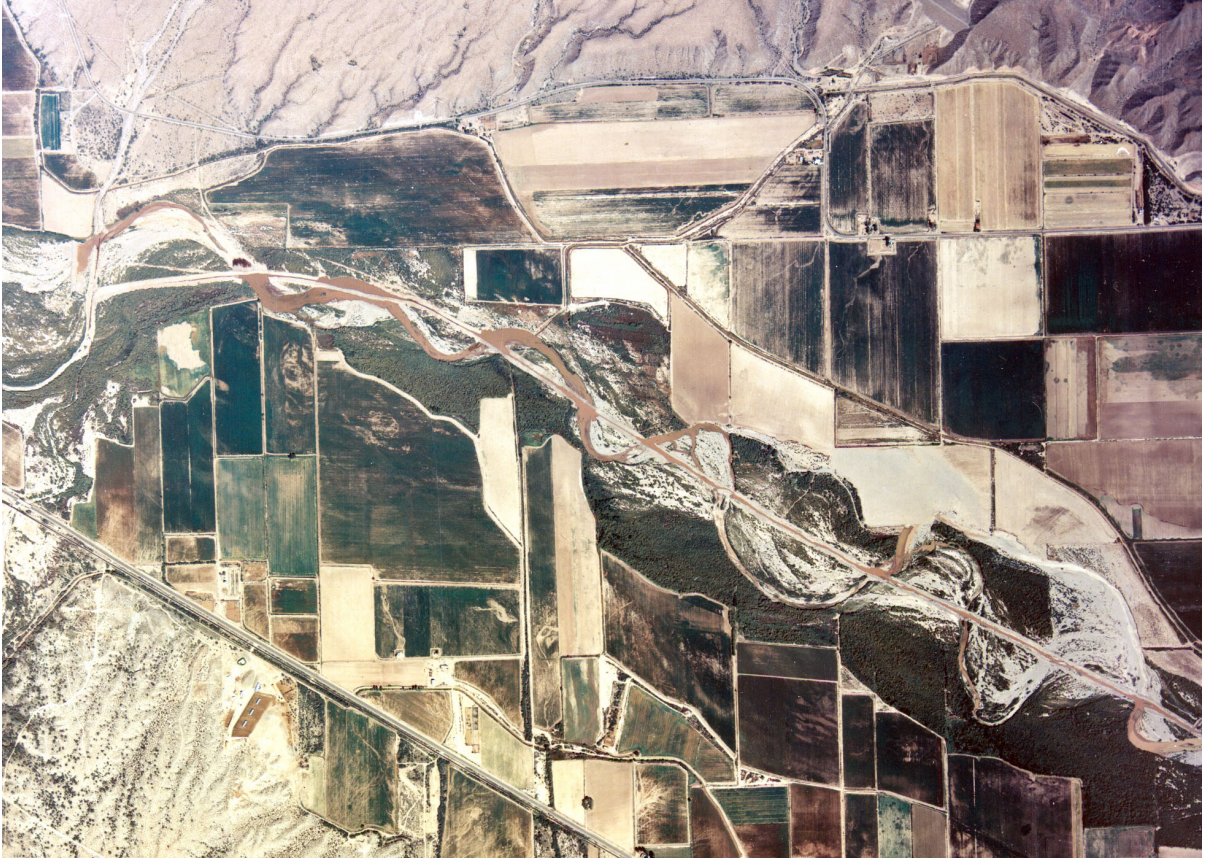
Figure 23. Channel straightening downstream of Curtis Diversion.

Erosion from Curtis Diversion to Markham Wash appears to be related to channel straightening during the 1970's (Geomorphic Map 8-9; Figure 23 and Figure 24). Following the initial channel straightening in the 1970's a new meander pattern was established as the river abandoned the artificial channel. This pattern developed through time as subsequent floods created new channel morphology. Thick vegetation in this reach was important in establishing the new channel morphology. Near the downstream end of the reach, flow repeatedly overtopped the embankments of the channel and flowed perpendicular to the overall flow direction, creating large loop-shaped erosion scars.

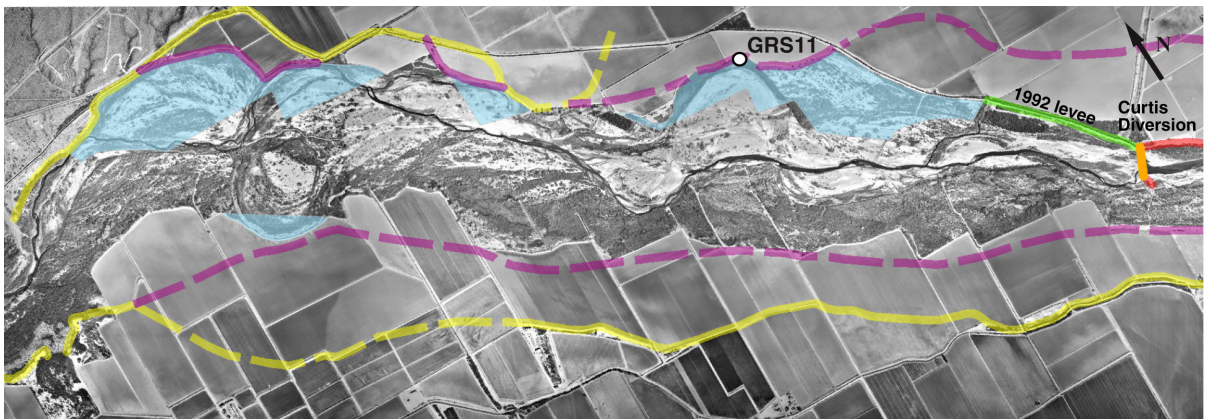
Figure 24. Curtis Diversion geomorphic map.

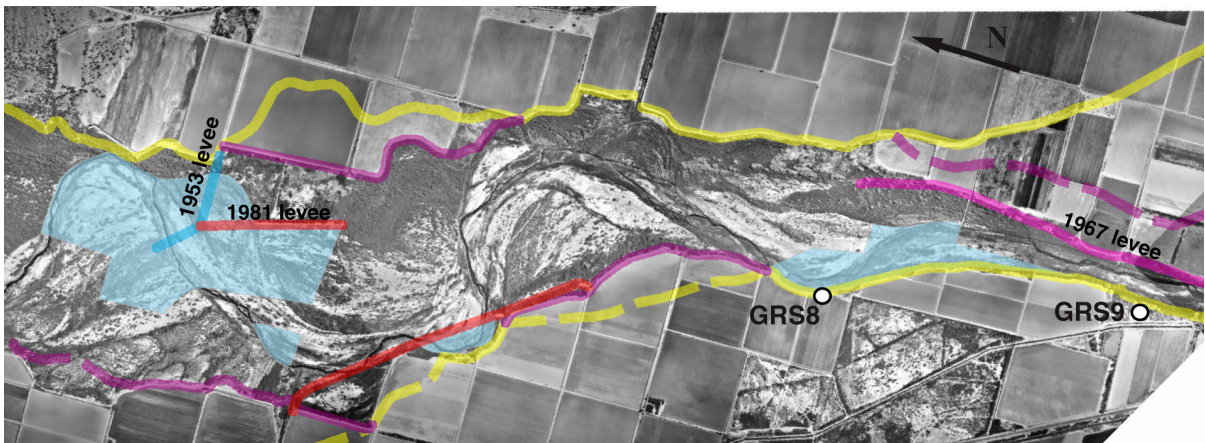
Figure 26. Eden Bridge geomorphic map.

downstream of the levee. The new large amplitude meander breached the 1981 levee on the right bank. Although the levee breach did not erode old alluvium, the active channel is presently adjacent to the Geomorphic Limit on the right bank. Previous channel positions, which breached the 1953 levee were most likely important in the new channel formation as well.

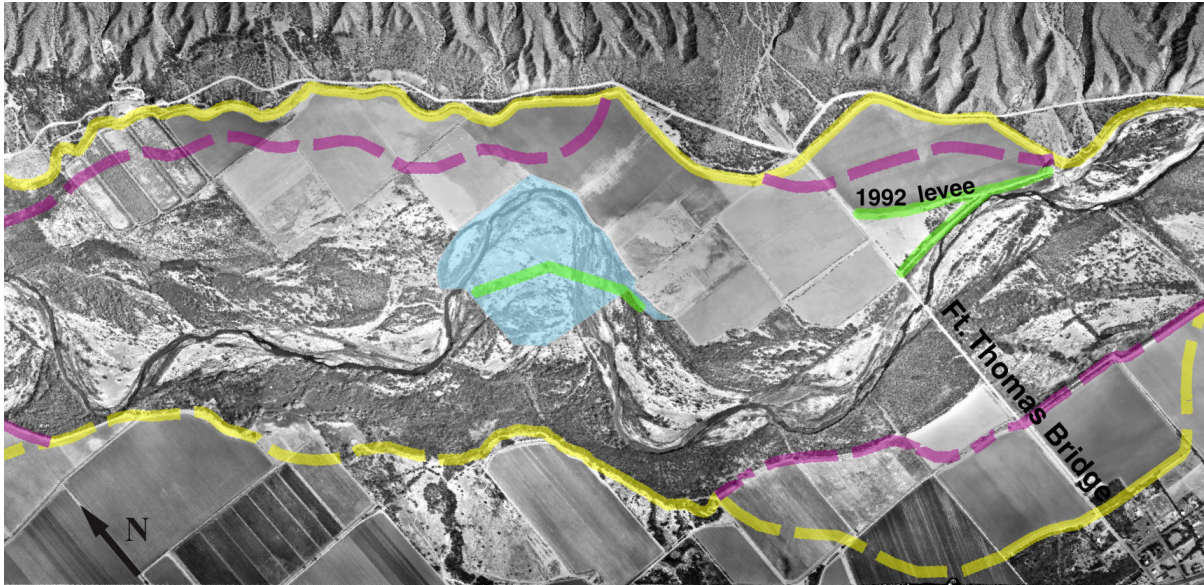
Figure 27. Fort Thomas Bridge geomorphic map.

The Fort Thomas reach extends from Fort Thomas Bridge to Goodwin Wash (Geomorphic Map 2-3; Figure 27). Property loss in this reach is associated with levees constructed in the 1990's. Although the 1983 flood caused extensive damage to agricultural fields by breaching the right bank levee upstream of Fort Thomas Bridge, it did not cause extensive channel change (Figure 28). Construction of a new levee in a similar location upstream of Fort Thomas Bridge prevented a breach during subsequent floods.
